Automatic Transmission/Transaxle Band and Servo Operation, Maintenance and Adjustments

North Montco
Technical Career Center

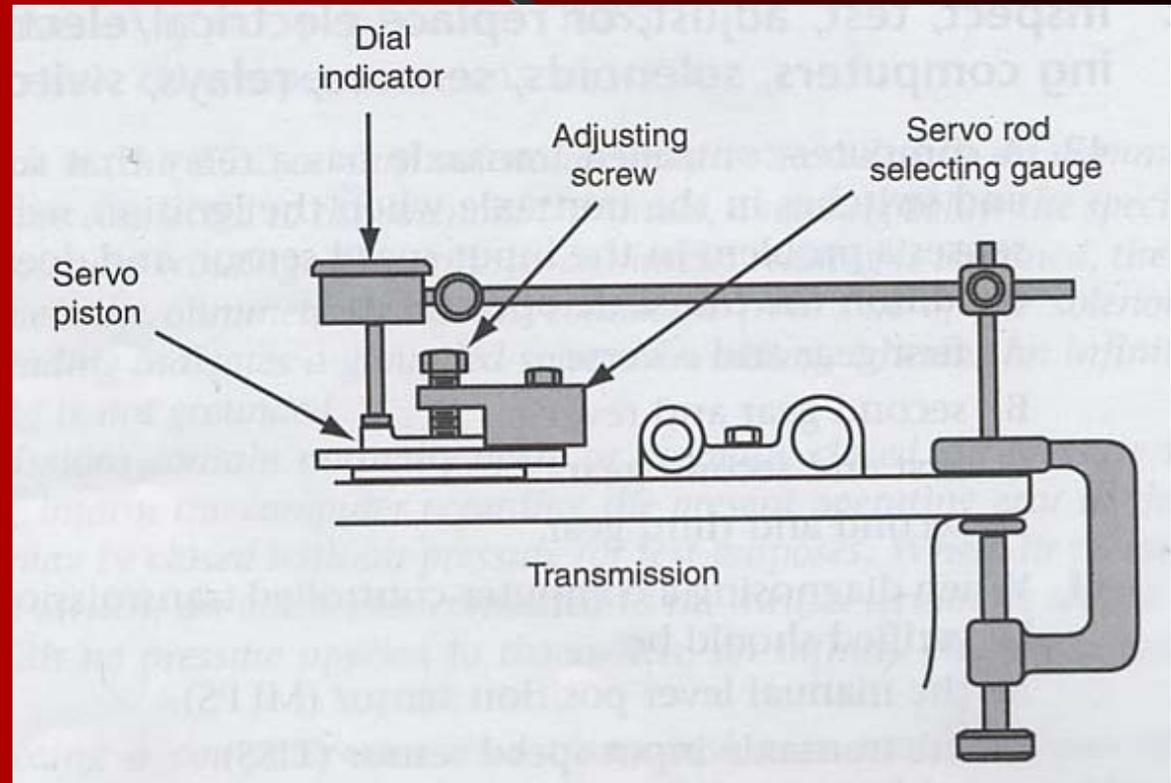
10. The set-up shown below is to determine the proper:

- a) Servo pin thickness
- b) Band anchor length
- c) Servo piston selection pin
- d) Servo piston adjustment

Servo piston thickness and band anchor length are not measured. In this illustration, the measurement being made is to determine the correct servo piston selective pin.
